Executive Summary

The property is a two storey semi detached house with a single storey extension to the rear with a converted garage to the side. The property is presented in good structural condition in general.

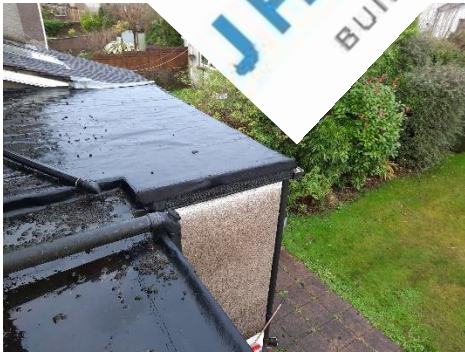
Fascia and soffits are of uPVC construction and appear in good order. The rear extension where the fascia is timber. There is evidence that these elements require cleaning.

3. There is ev. facia to the rear extension, this should be replaced.

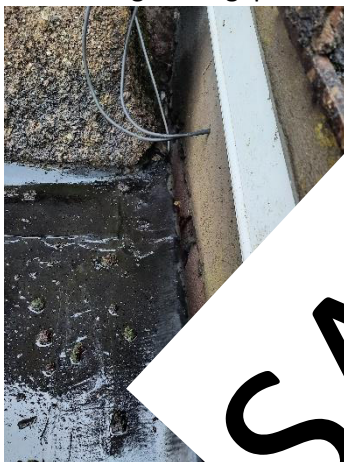
The leadwork stops short and there is a gap between the property's pitched roof and the boundary wall / adjoining property's pitched roof. This allows the entry of insects or rodents into the void and the garage.

4. The leadwork stops short and there is a gap existing boundary wall / adjoining property's pitched roof the entry of insects or rodents into the void & maintaining an air gap.

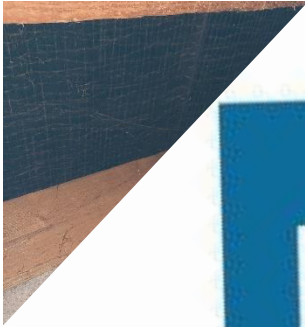
The party wall is of masonry constructed up tight to the underside of the felt. Within the party wall the roof is not fully closed off. This should be sealed with a suitable sealant and sealant should suffice

5. There is minor gaps in the par
foam and sealant should si

use of fire proof expanding
is quite small.

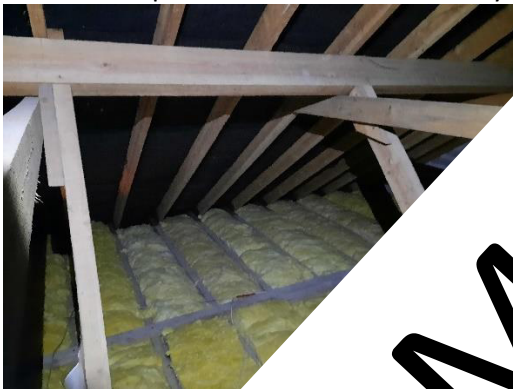
7. The existing roof insulation, while in good condition it do
approximately 300mm thick. If additional insulation w
costs and improve the level comfortability.

+ current guidelines of
ould reduce heating

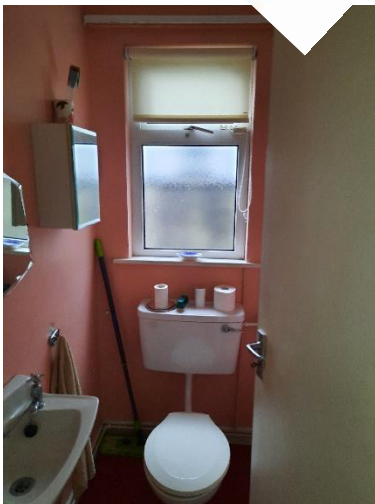
No extract fan is provided in the bathroom to reduce the

11. No extract fan is reduce the likelihood

WC. Consideration should be given to improving this to condensation forming within this area.

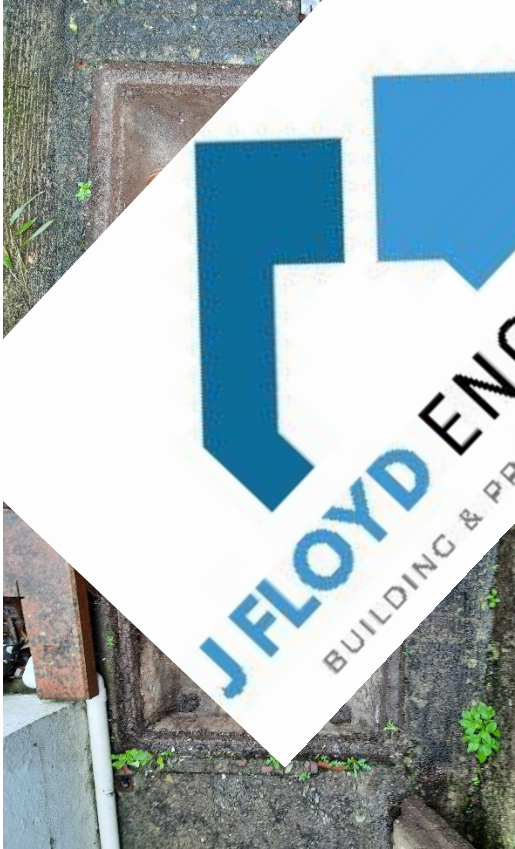
The foul water drain was opened and the manhole should be re-benched also. The manhole is not adequately supported and suited to the purpose.

13. The foul water drain was open

amount of silt built up here.

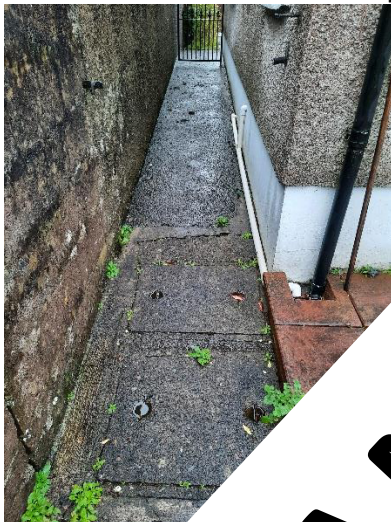
15. Waste pipes serving the ground floor shower room and WC are not adequately supported and suitable brackets should be provided. Manhole cover should be replaced.
